INSTRUCTION SHEET

DUKE® 60, A60, AND B60 LANDPLANES FAA Approved Airplane Flight Manual Supplement for

FLIGHT IN KNOWN ICING CONDITIONS

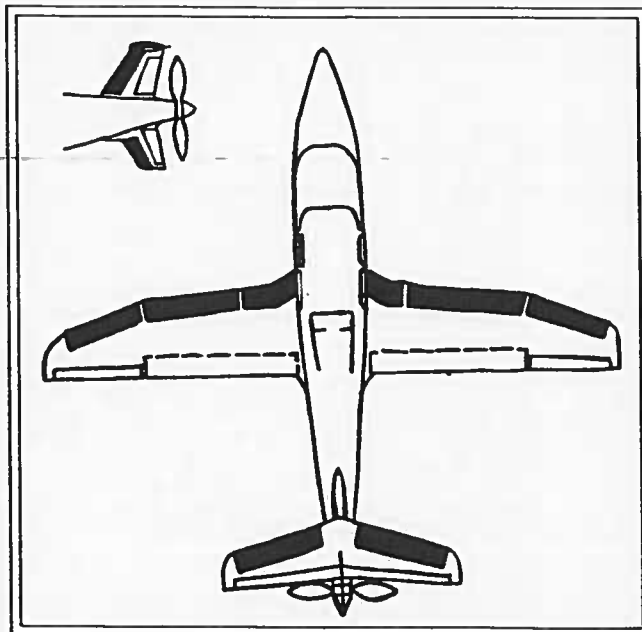
Grob GF 250 with PIIP de-icer locations shown

The PIIP system, in development since 1986 (see *The Leading Edge* Volume 5, Issue 4, August 1989) and patented by BFG, utilizes high pressure pneumatic pulses to provide ice protection. This system will be used on all leading edges of the GF 250, which include the wings, horizontal stabilizers and vertical fin. Installation on the new GF 250 is the first application for the PIIP system.

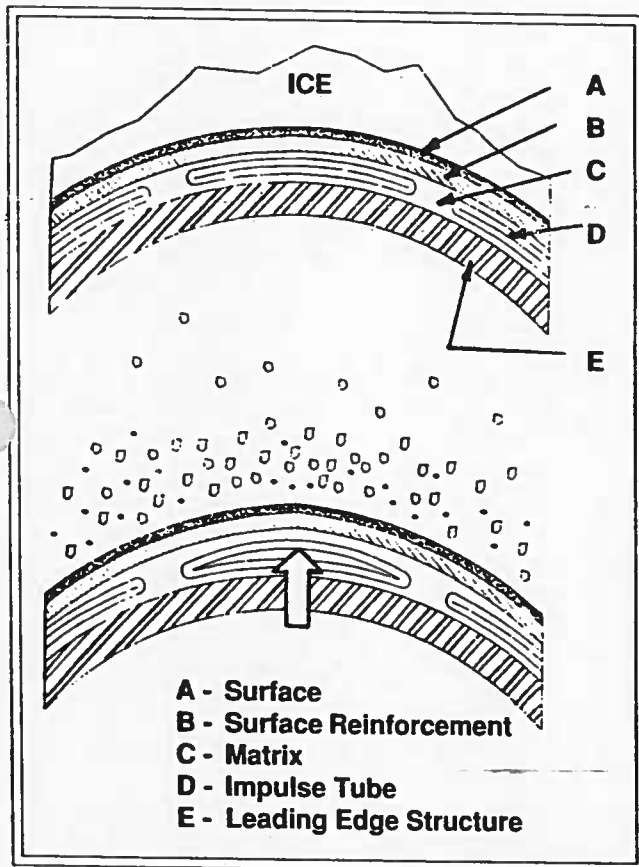
PIIP integrated composite leading edge assembly

The PIIP system includes a low-power, mechanical de-icer of all composite construction, with a metallic, thermoplastic or other suitable erosion surface. It can be powered by a compressor or air reservoir. Grob's GF 250 will use an air reservoir, virtually eliminating the need for aircraft power to operate the PIIP system.

While BFG's traditional pneumatic de-icers are designed to be operated after ice builds up to about .250" or greater, the PIIP system can remove as little as .040" ice accumulation, resulting in very small ice shed particles. For this reason, the system is being considered for use on military and commercial aircraft for engine inlets and wing leading edges.

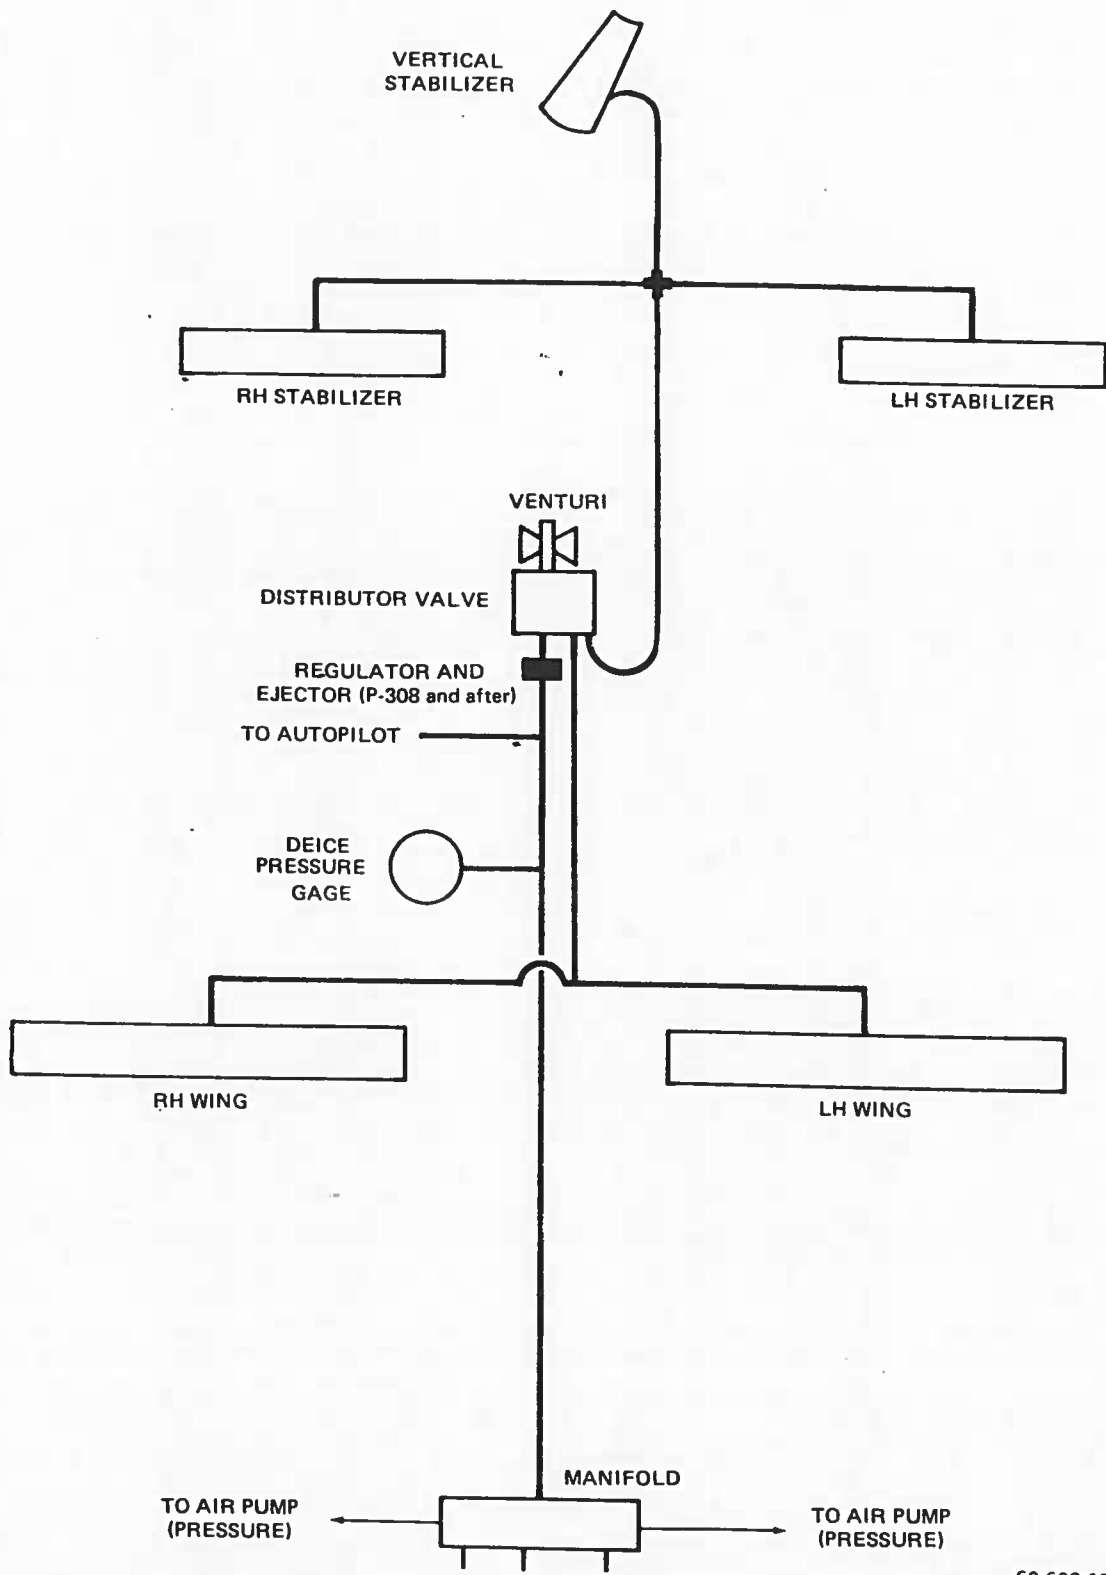
60-603-17A

Airfoil Deice System Schematic
Figure 1
